Inspection Report Minerals Regulatory Program February 3, 2010

Mine Name: Neal 1-2-3	Permit Number: S/047/0063
Operator Name: Ziegler Chemical & Minerals	Inspection Date: November 4, 2009
Inspector(s): L Heppler	Time: 12:30 pm
Other Participants: Roland Hansen – BLM , Bob - Ziegler	Mine Status: Inactive

Purpose of Inspection: Routine annual Inspection. This site was inspected as a small mine site on 04/20/2007

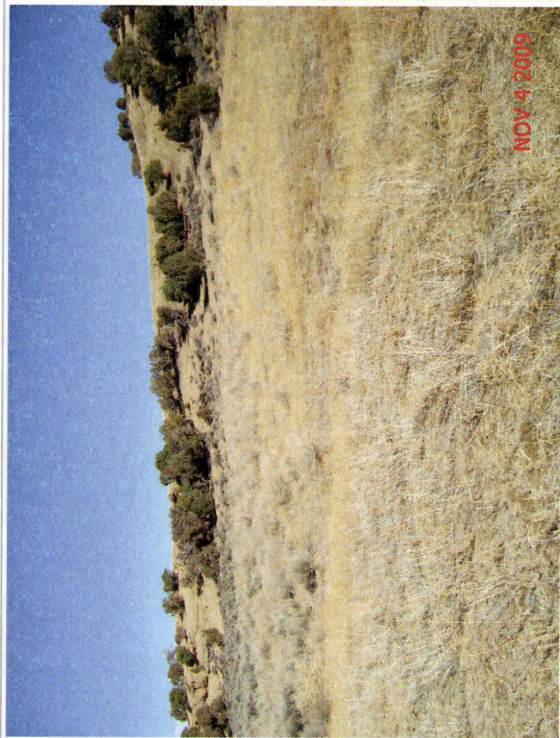
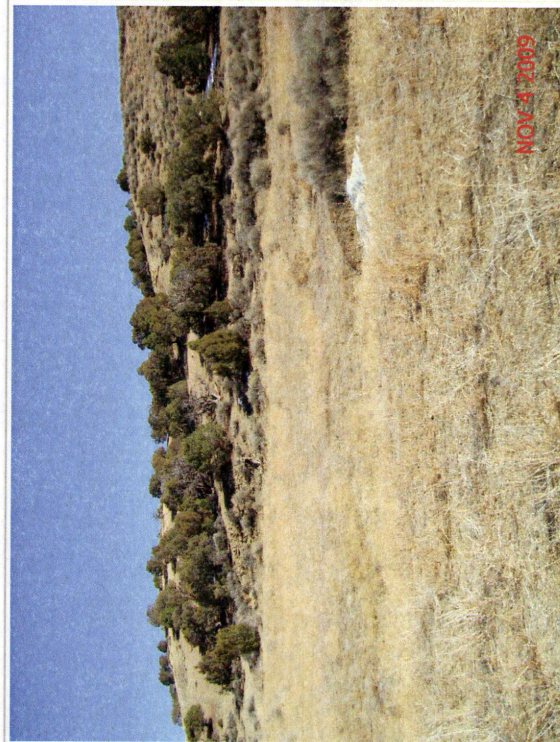
First Neal site visited

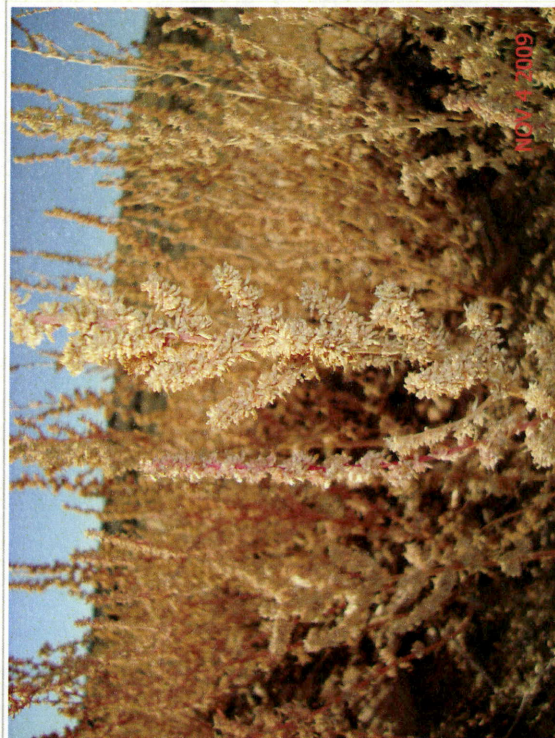
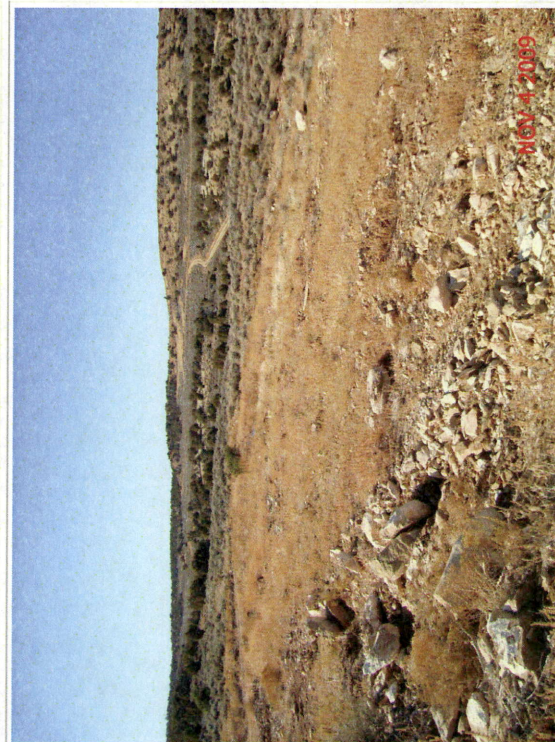
Neal 3

Conclusions and Recommendations: Operator needs eliminate the noxious weed and reseed the area in the fall at the Neal 3. OGM to continue annual inspections and monitor the site when in the area.
